# Manhole Inspection Summary

Manhole # S23Q\_\_001MH

Insp Date: **4/4/08 2:09 PM**

**Location** Address: **1501 WASHINGTON BLVD.**

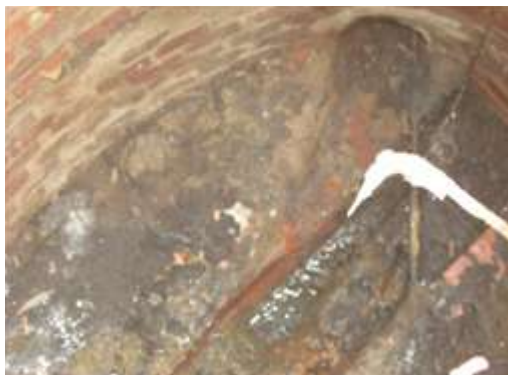
Defect 5

Condition: ☐ Sound ☐ Cracked ☐ Root Intrusion ☐ Deteriorated ☐ Leaks ☒ Debris

HEAVY DEBRIS ON BENCH AND SOME DEBRIS IN THE CHANNEL

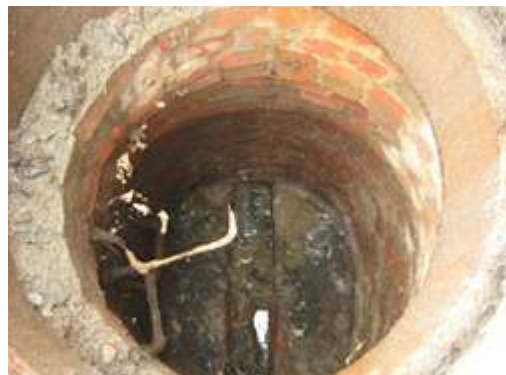
Defect 2

Infiltration: ☐ None ☐ Joint ☐ Cracks ☒ Mortar ☐ Roots ☐ Wall

Infiltration: ☐ None ☐ Joint ☐ Cracks ☐ Mortar ☐ Roots ☒ Wall

Count: **3** Missing: **3** ☒ Corroded

steps missing/corroded, signs of infiltration at chimney mortar, corbel wall, & barrel wall

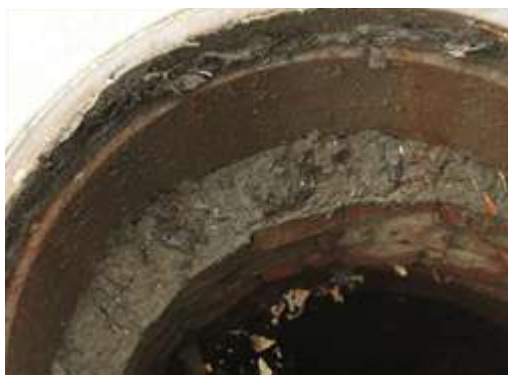
Defect 1

Offset: **2** (in.)

2 IN FRAME OFFSET

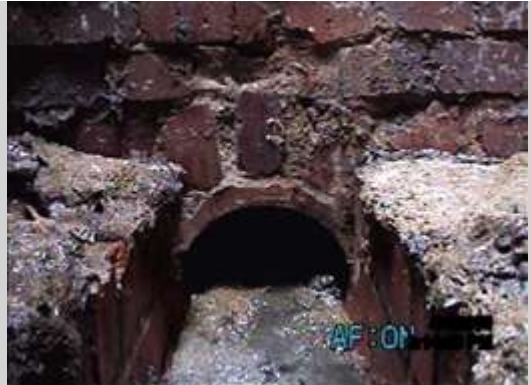
12 O'Clock Outflow

8 in. Circular Gravity Sewer  
Pipe Out @ 12 O'Clock

Pipe Height: **8.4** (in.) Rod and Bar (Angled)  
Pipe Material: **Clay** ☐ Pipe Lined  
Invert Depth: **7.30** (ft.) Flow Characteristics: **None**  
Deposits: ☐ None ☐ Mud ☒ **Sludge** ☐ Debris ☐ Grease  
Silt Depth: **4** (in.) Deposits Extent: **Medium**  
Infiltration: **None** Pipe Seal Cond: **Unknown**

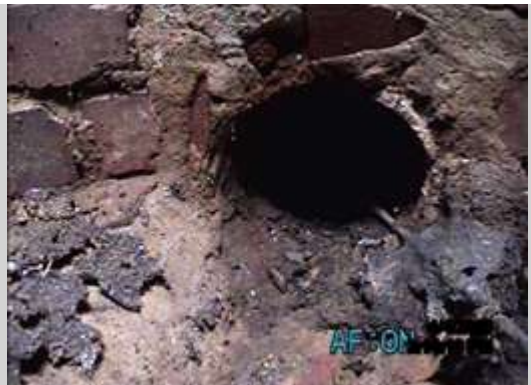
5 O'Clock Inflow

6 in. Circular Gravity Sewer  
Pipe In @ 5 O'Clock

Pipe Height: **6** (in.) Rod and Bar (Angled)  
Pipe Material: **Clay** ☐ Pipe Lined  
Invert Depth: **6.74** (ft.) Flow Characteristics: **None**  
Deposits: ☐ None ☐ Mud ☒ **Sludge** ☐ Debris ☐ Grease  
Silt Depth: **4** (in.) Deposits Extent: **Medium**  
Infiltration: **None** Pipe Seal Cond: **Unknown**
